SAFETY ALERT #417

Dated: Sunday, 28th FEBRUARY 2010

Title: FAILURE OF PERMIT TO WORK

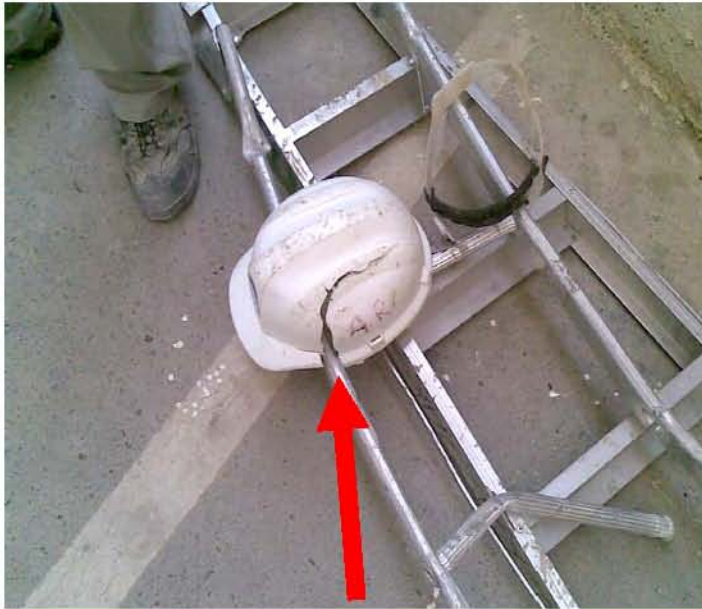
The helmet of the injured person was broken by the impact of the block.

This accident occurred at a (G+24 floor tower site) which involved one labourer, who was fitting duct inside a riser on the 7th Floor. The accident was caused by the failure & negligence of the main contractor who 'Permitted the Subcontractor to Work' inside the riser, however, at the same time a masonry team was also working in the same riser at one of the upper floors (21st floor). A hollow core block fell from the 21st floor and broke the overhead protection covering the 9th floor. The block continued to fall & hit the worker who was working on the 7th floor on the head. The worker was at once hospitalized and was found that his shoulder bone was broken. The injured person was given exemption from work for 3 months.

Investigate to correct failure of the PTW and prevent the drop of equipment from height. Risk assessment must be reviewed to address corrective and preventative actions.

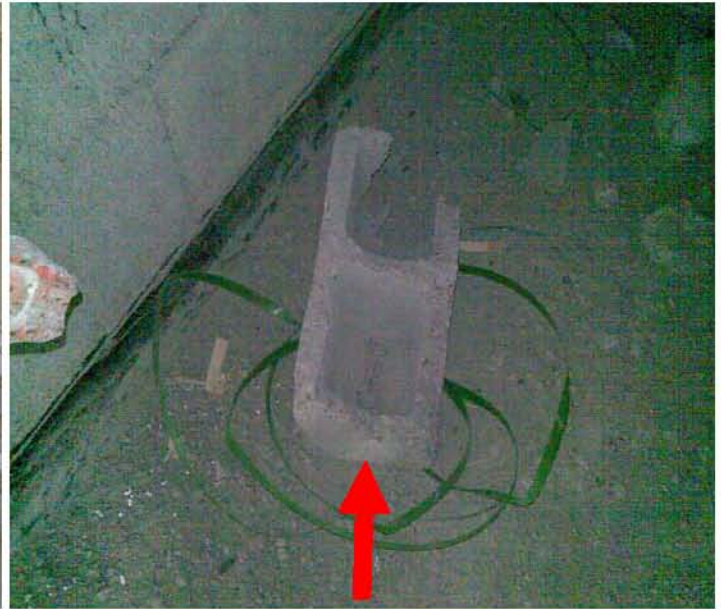
Piece of block which fell inside the riser.
