WASIT PROJECT SAFETY ALERT

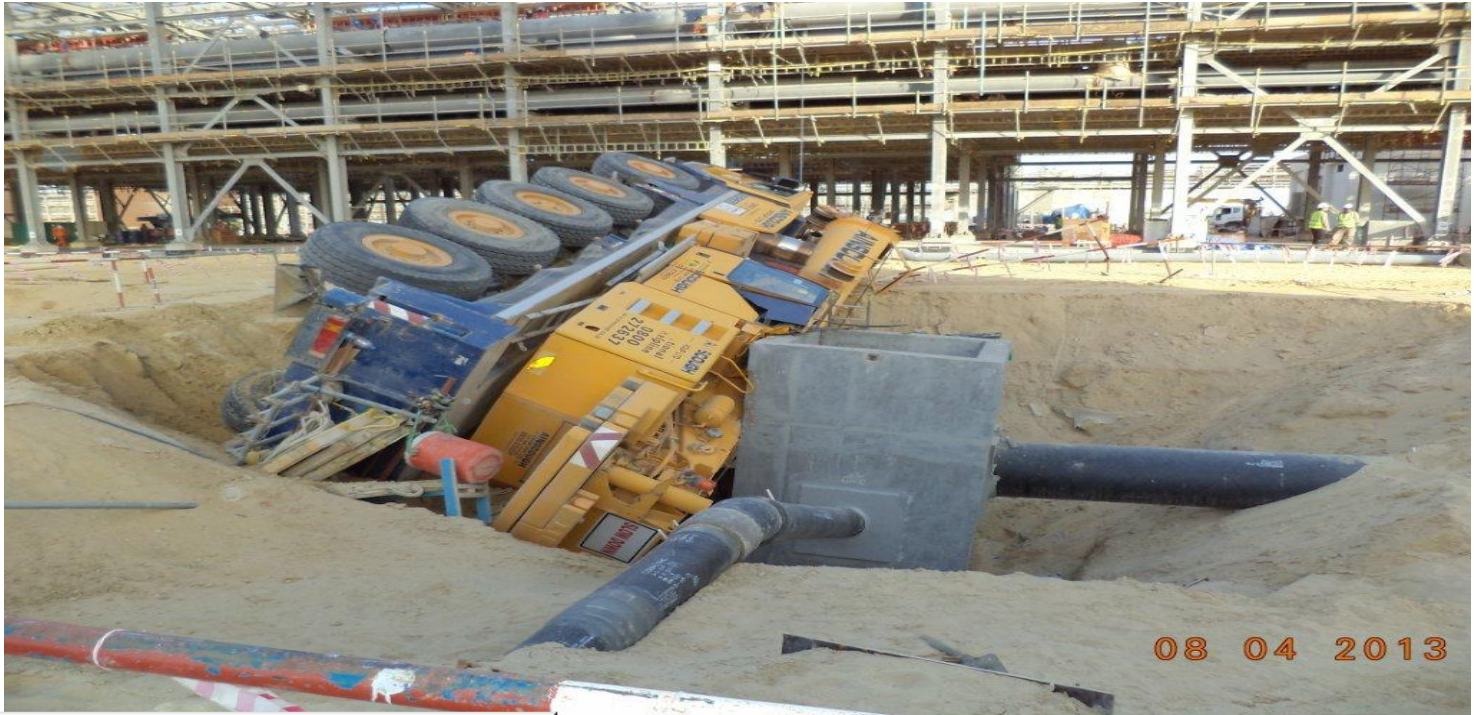
A truck-mounted 70T crane is trying to maneuver out of his work area traversing a semi-compacted, narrow access road between two excavations.

- Cranes and other heavy equipment too near the edges of excavations.
- No proper access for cranes and other heavy equipment to move around on site due to too many open excavations.

- ✓ A proper pre-activity assessment of the different work areas or locations where cranes and other heavy equipment are to be used to determine if the equipment are placed or moved into high risk areas;

- ✓ All areas where cranes have to be set up for lifting activities will be assessed to ensure that soil compaction is done according to Aramco standards and requirements, i.e. *soil compaction tests done on so called compacted soil.*

- ✓ All HE/cranes work areas to be assessed to ensure correct distance from excavations are maintained as per GI. 7.028, paragraph 7.11;
- ✓ A lay-out will be made of the setup of the crane in relation to the excavation(s) nearby and this REVIEWED & APPROVED lay-out shall be attached to the work permit for that lifting activity;

- ✓ Any re-positioning of cranes around excavated areas shall be done only after a new lay-out indicating the new position and/or travel route have been reviewed and approved.

Ex.: A crane has to move from one area to another & has to pass b/n two excavations that are 3m deep, the crane must maintain 6m distance from each excavation. If the distance to the edge of the excavations is only 4m, the crane SHALL NOT be allowed to move b/n these excavations.(GI. 7.028).
