PROJECT SAFETY ALERT

No- 013

Hose Coupling Failure

AREA : QCS

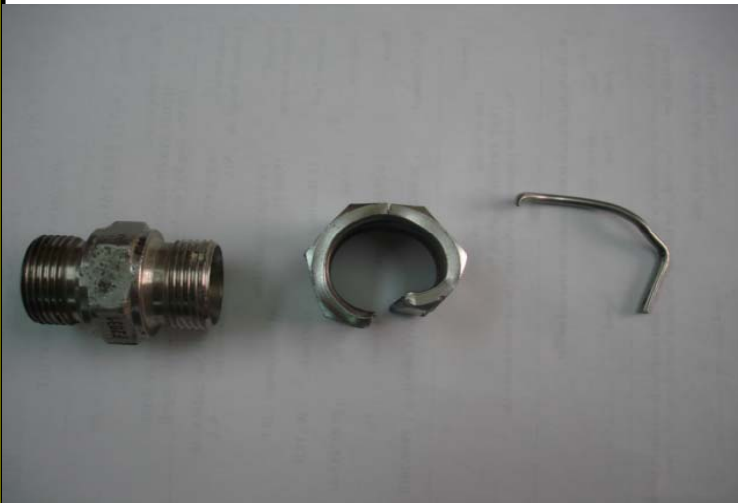
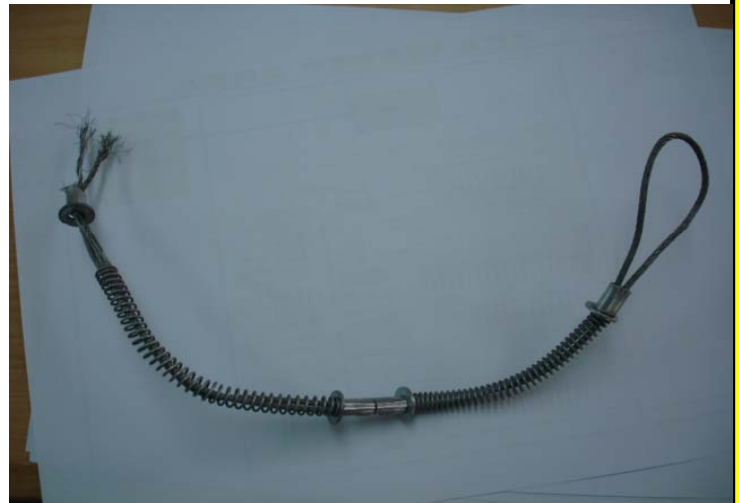
On 17th October 2009 around 15:00 hours, during the hydro milling preparation work for Train 7 N2 compressor lube oil interconnecting line @ south side of Train 7 N2 L/O skid, the high pressure hose coupling connection failed and broke off. The safety hose whip check installed between the connections also failed and the hose whipped and struck one of the operators across both legs thigh height causing abrasion & bruising, who was standing approx 1.5 - 2m away from the connection at.

- During pressurization of hydro test, pneumatic test, hydro milling, etc all personnel must stand at a safe distance from connection points in case of failure.
- All safety whip checks to be pre- inspected prior to installation to ensure they are functioning correctly and no visual defects are present.
- All pressure testing must be controlled by the responsible testing group ensuring sufficient barricaded area for the test and appropriate signage & warning tape displayed to keep non essential personnel out.
